***1234 Sample Ave,  
Columbus, OH 43123***

**INSPECTION PREPARED FOR:**  
Smith John & Jane

**INSPECTOR: Chad Auber**

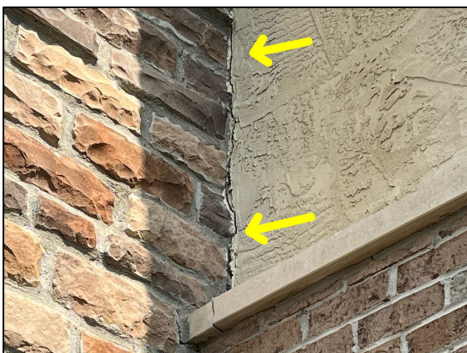
- **Repair: The siding is lacking proper sealant joints at intersections of dissimilar materials. This condition should be repaired to help prevent moisture intrusion. (Brick meets stucco, wood brick, and window trim intersections, etc.)**

The siding is lacking proper sealant joints at intersections (Brick meets stucco)

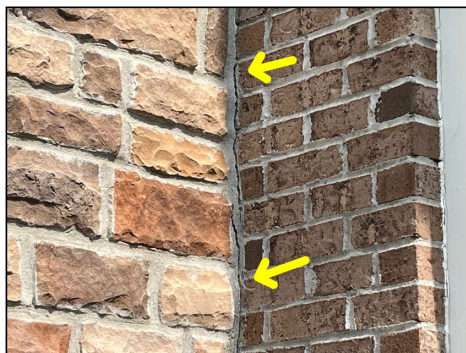
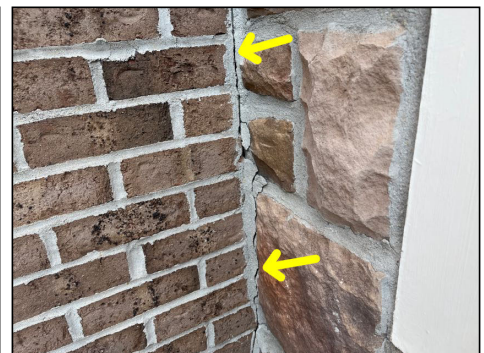
- **Repair: Localized pointing of deteriorated mortar between the bricks and stone of the exterior walls is advisable to prevent further deterioration. (Front of house)**

Cracked brick mortar requires repair

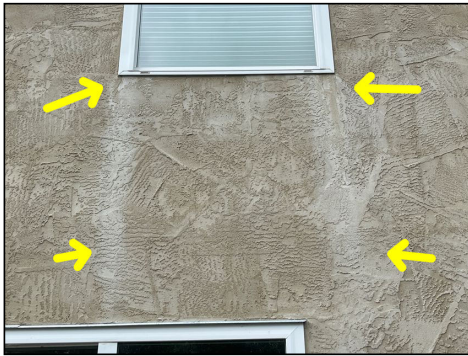
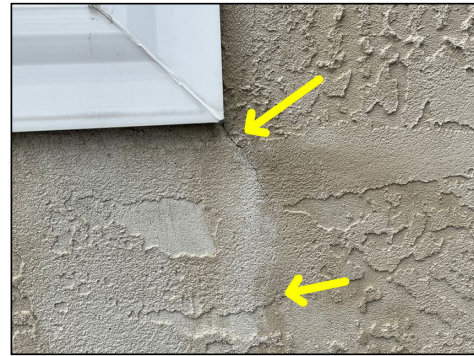
- **Repair: Localized minor cracking and staining of the stucco exterior walls should be repaired at (rear below windows). There is extra risk of hidden damage in such areas caused by previous or present leaks that should be repaired. It is recommended that a qualified stucco contractor be consulted to further evaluate the stucco system to determine if additional hidden damage may be present. Unfortunately, stucco/stone exteriors are very vulnerable to moisture intrusion, and can cause damage that is not visible in the course of a home inspection.**

Minor cracking and staining of the stucco exterior walls at (rear below windows).

Cracking and water stains of rear stucco wall below windows

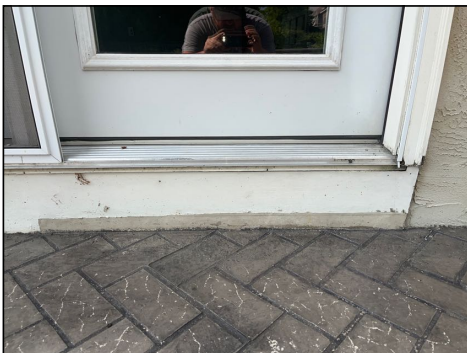
Rear patio door kickplate needs repainted

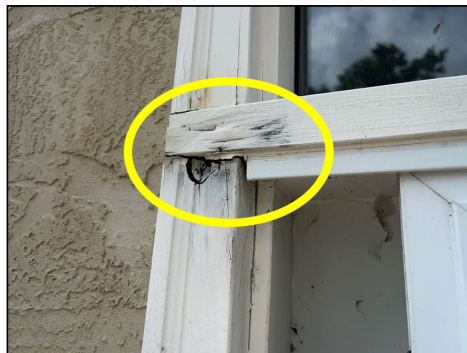
Exterior door frame at top left corner shows signs of wood rot (Rear patio door)

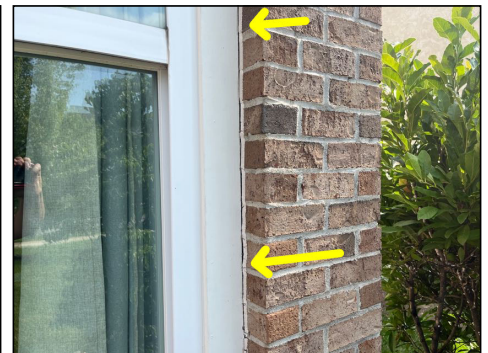
Caulking needed to front windows

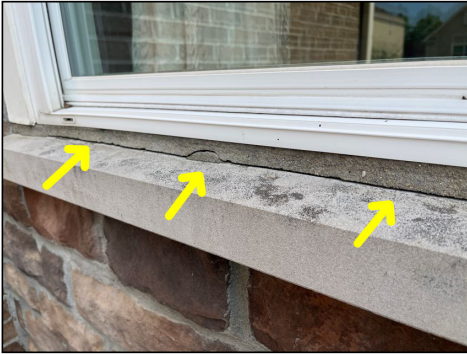
The front dining room window sill mortar, shows evidence of cracking.

Page 9	Exterior doors / windows observation	<ul style="list-style-type: none"> <li>• <b>Repair/Replace: The front dining room window sill mortar, shows evidence of cracking. Recommend further evaluation from a licensed contractor for repairs needed.</b></li> <li>• <b>Repair/Replace: Exterior door frame at top left corner shows signs of wood rot, repair or replace as needed. (Rear patio door)</b></li> </ul>

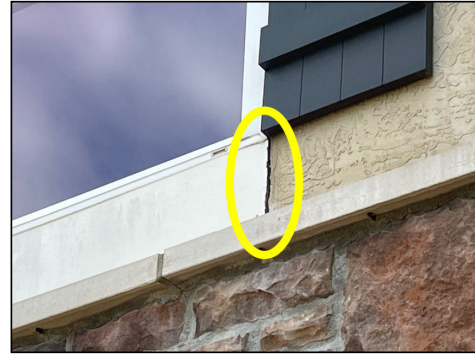
Pain maintenance needs to wood frame windows

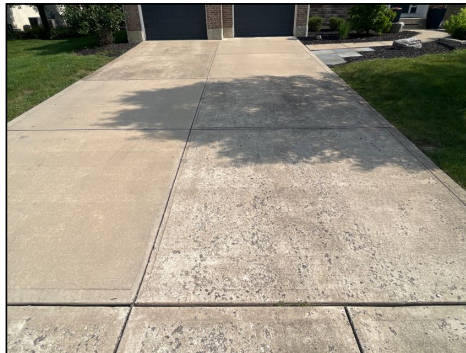
- **Monitor/Replace:** The driveway surface is in a deteriorated condition. Resurfacing is necessary to correct this condition.

Driveway surface deterioration observed

- **Improve:** Concrete driveways should be power washed and sealed every 3-5 years or as needed to help prevent damage and deterioration.

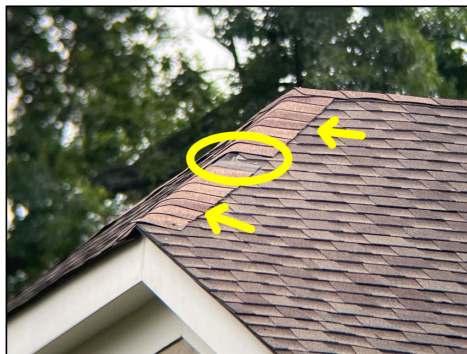
Wind damaged and missing shingle observed at (front Southwest corner)

• **Repair/Replace: Minor repairs to the roofing are needed. Damaged and missing roofing material should be repaired. All roof penetrations should be examined and sealed as necessary. Aging or loose flashing can cause leaks, these items should be maintained periodically to prevent water intrusion.**

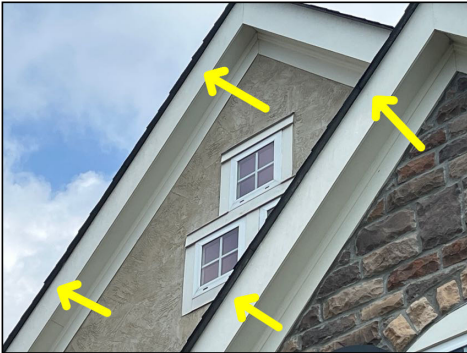
Missing drip edge flashing is not required but is recommended.

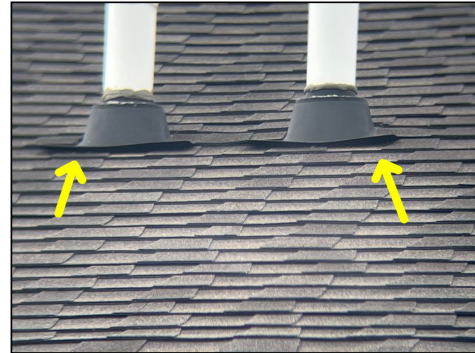
The (rear passive radon pipe and waste vent stack) flashing is loose

Page 13	Roof flashing observation	<ul style="list-style-type: none"> <li>• <b>Repair/Replace:</b> The (rear passive radon pipe and waste vent stack) flashing is loose and should be re-secured to avoid leaks.</li> </ul>
<b>Interior</b>		
Page 16	Window observation	<ul style="list-style-type: none"> <li>• <b>Repair/Replace:</b> The (Southwest bedroom) window counter balance should be adjusted to operate properly and prevent window from dropping.</li> </ul>
Page 16	Doors observation	<ul style="list-style-type: none"> <li>• <b>Repair/Replace:</b> Damaged, non-functional or missing door hardware should be improved. (Several door locks do not work properly at 2nd floor bedrooms and bathroom)</li> </ul>
<b>Plumbing</b>		
Page 22	Supply Plumbing	<ul style="list-style-type: none"> <li>• <b>Possible Repair/Replace:</b> The supply piping appears have occurred prior leakage (at front wall of basement at main water supply line wall penetration). This area has been temporarily sealed with putty and is not a permanent solution. Recommend consulting with a licensed waterproofing contractor in regards to repairs and options to avoid additional leakage to this area and any potential underlying drainage issues to this area of the home. One cannot predict the frequency or any future leakage this area may occur under the scope of a one time inspection.</li> <li>• <b>Repair/Replace:</b> The laundry room clothes washer valve is leaking and should be repaired.</li> </ul>

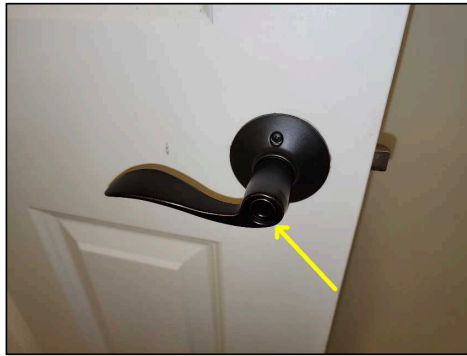
Door lock does not work properly

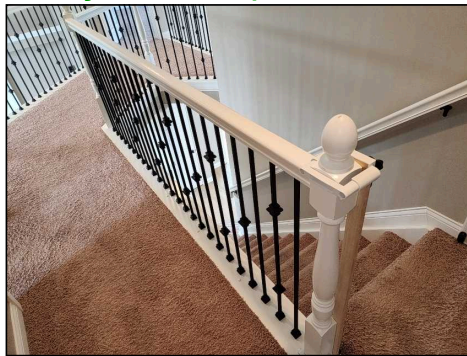
- **Monitor: The railing for the stairway is loose. (2nd floor hallway)**

Loose railing

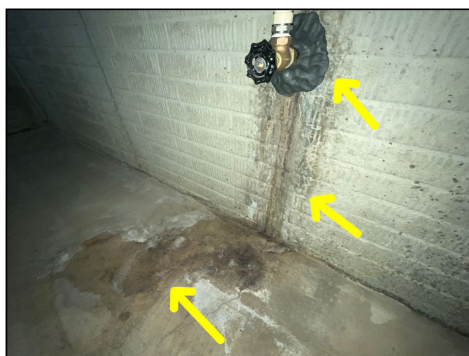
• **Possible Repair/Replace**: The supply piping appears have occurred prior leakage (at front wall of basement at main water supply line wall penetration). This area has been temporarily sealed with putty and is not a permanent solution. Recommend consulting with a licensed waterproofing contractor in regards to repairs and options to avoid additional leakage to this area and any potential underlying drainage issues to this area of the home. One cannot predict the frequency or any future leakage this area may occur under the scope of a one time inspection.

The supply piping appears have occurred prior leakage (at front wall of basement at main water supply line wall penetration).

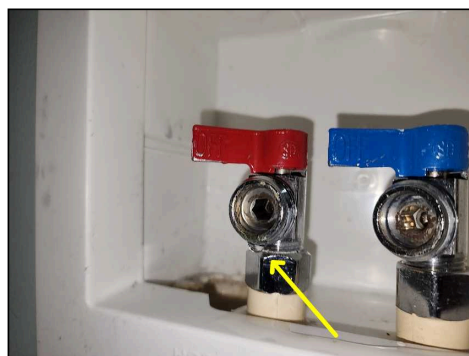
• **Repair/Replace**: The laundry room clothes washer valve is leaking and should be repaired.

Supply valve leaks

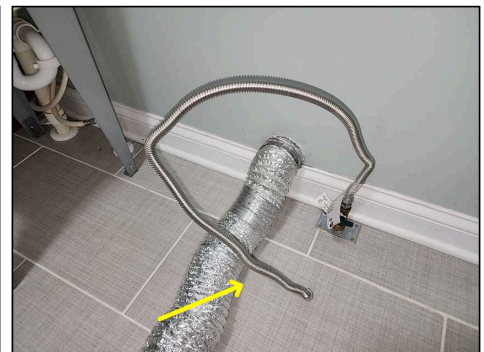
Unused gas lines should be capped

Page 23	Fuel Storage and Distribution observation	<ul style="list-style-type: none"> <li>• <b>Repair:</b> Unused gas lines should be capped to help prevent leaks. (Laundry room)</li> </ul>
Page 24	Other Components observation	<ul style="list-style-type: none"> <li>• <b>Repair:</b> The discharge line for the sump pump is not connected at outside wall. This is caused by pipe settling below grade (common).</li> <li>• <b>Repair:</b> The passive radon pipe is capped above the roof and should be removed.</li> </ul>
Page 24	Plumbing Fixtures	<ul style="list-style-type: none"> <li>• <b>Repair/Replace:</b> The master bathroom bathtub spout leaks at the wall.</li> </ul>
<b>Structure</b>		
Page 30	Floor structure observation	<ul style="list-style-type: none"> <li>• <b>Repair/Replace:</b> An unknown substance that appears to be mold was observed on floor joists in the (front basement unfinished storage room). This is usually due to improper ventilation. One (1) square foot of free vent area should be provided for every five hundred (500) square feet of crawl space. Proper ventilation helps control humidity and reduces the risk of rot. Crawl spaces can be vented to the building interior or exterior, depending on crawl space configuration. Mold like substance should be sealed or removed. (Recommend further testing to help identify the substance and the scope of clean up that may be needed)</li> </ul>

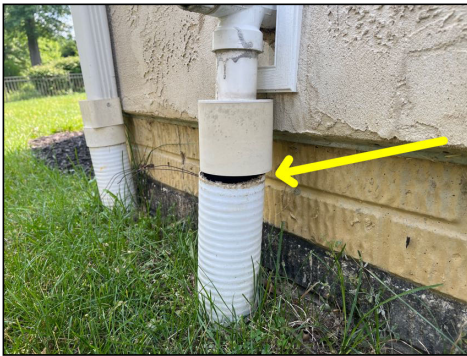
- **Repair:** The discharge line for the sump pump is not connected at outside wall. This is caused by pipe settling below grade (common).

The discharge line for the sump pump is not connected at outside wall.

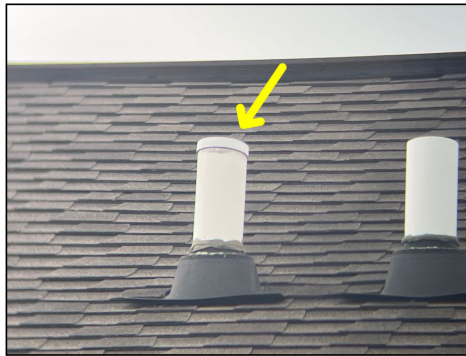
- **Repair:** The passive radon pipe is capped above the roof and should be removed.

The passive radon pipe is capped above the roof and should be removed.

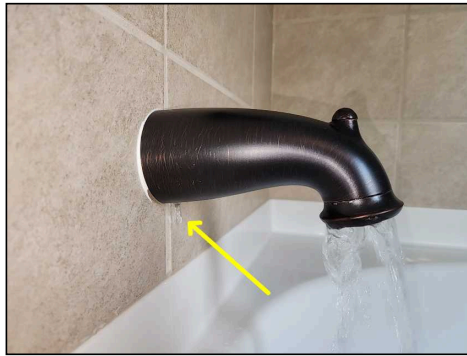
- **Repair/Replace:** The master bathroom bathtub spout leaks at the wall.

Bathtub spout leaks

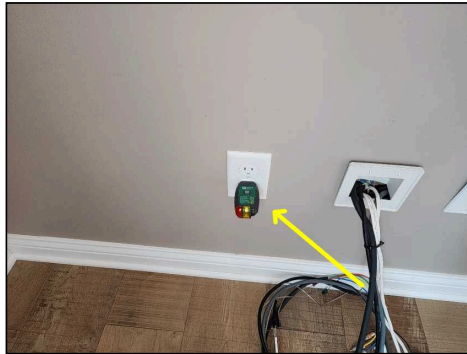
• **Safety Issue: An outlet has reversed polarity (i.e. it is wired backwards). This outlet and the circuit should be investigated and repaired as necessary. (Family room northeast corner).**

Outlet has reversed polarity (family room northeast corner)

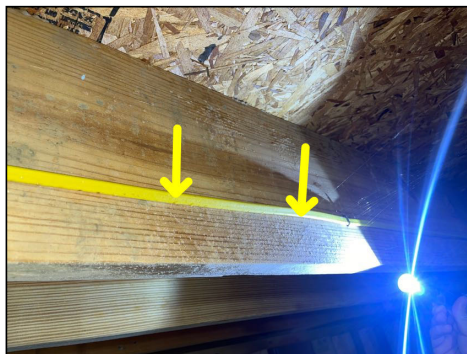
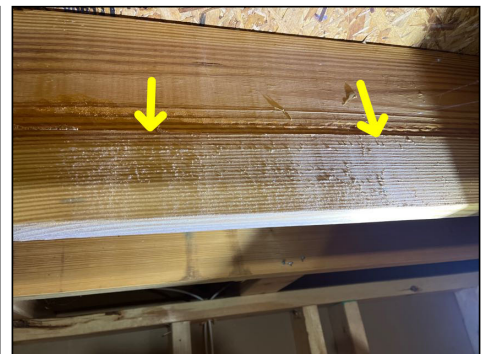
- **Repair/Replace:** An unknown substance that appears to be mold was observed on floor joists in the (front basement unfinished storage room). This is usually due to improper ventilation. One (1) square foot of free vent area should be provided for every five hundred (500) square feet of crawl space. Proper ventilation helps control humidity and reduces the risk of rot. Crawl spaces can be vented to the building interior or exterior, depending on crawl space configuration. Mold like substance should be sealed or removed. (Recommend further testing to help identify the substance and the scope of clean up that may be needed)

What appears to be possible mold growth (front basement unfinished storage room)
