## 100 MAIN STREET

**100 Main Street**

INSPECTION DATE

**01/01/2026 9:00AM**

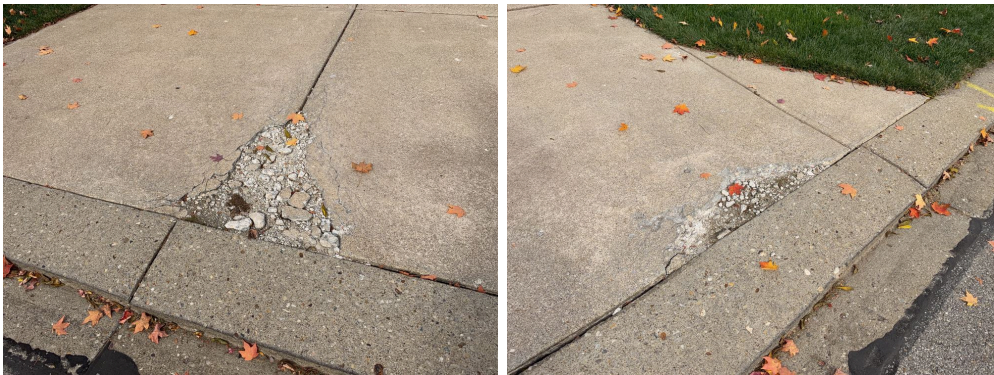
#### Surface Deterioration

The driveway was observed to have areas of deterioration, cracking, surface wear. Continued weather exposure and vehicle traffic may contribute to further deterioration over time. Recommend repairing or resurfacing damaged areas as needed and maintaining/sealing cracks to help reduce continued deterioration and moisture penetration.

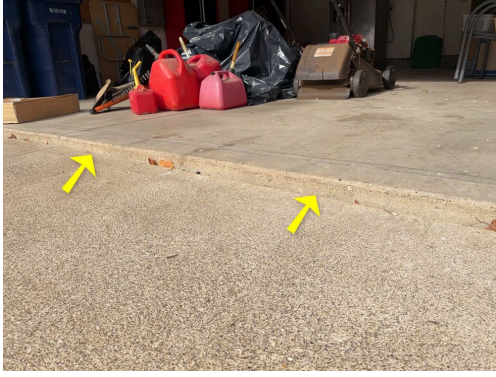
#### Driveway settlement at garage

Significant settlement was observed where the driveway meets the garage slab, resulting in an uneven transition and noticeable elevation difference. This condition may continue to worsen over time and can contribute to drainage concerns, trip hazards, and difficulty entering the garage. Recommend further evaluation and repair by a qualified concrete or driveway contractor.

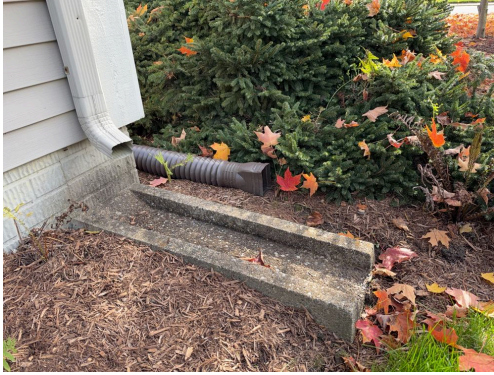
Downspouts should discharge water at least five (5) feet from the house. Storm water should be encouraged to flow away from the building at the point of discharge.

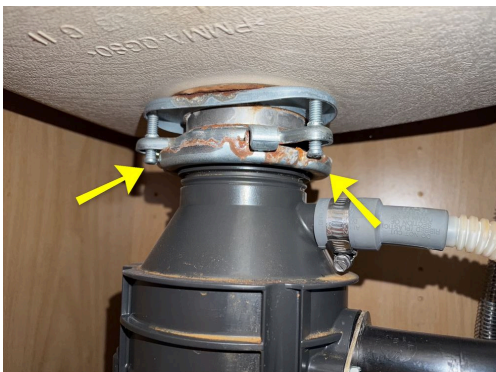
#### Disposal was old and rusting

The waste disposer was observed to be old and showing signs of rusting. Rust may indicate deterioration and can contribute to leakage or eventual failure of the appliance.

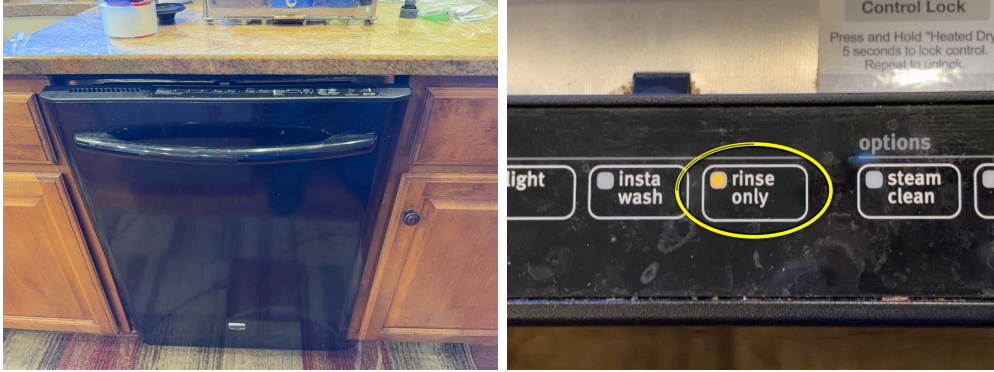
### Dishwasher tested operational

The dishwasher was tested through a rinse cycle at time of inspection. The dishwasher operated no leaks were observed at time of inspection. Please note that not all functions and cycles are tested during inspection.

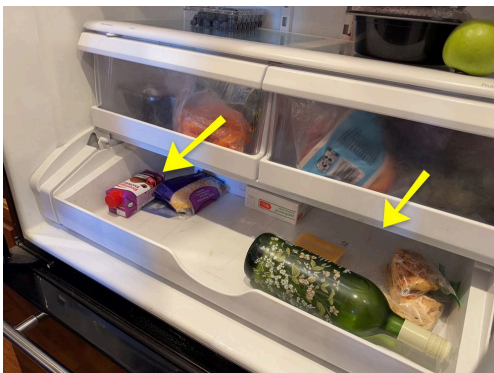
The plastic cover for the refrigerator crisper drawer was missing. This may reduce the drawer's intended function and could allow stored items to be less protected from spills or damage. Replacement of the cover with a compatible component is recommended.

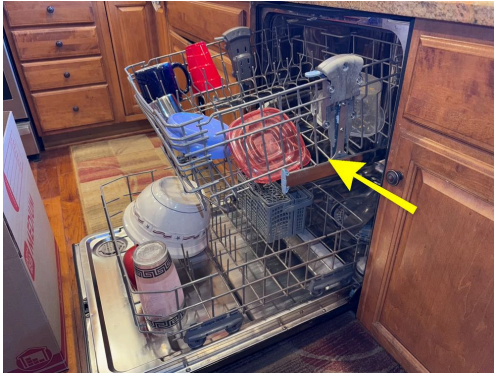
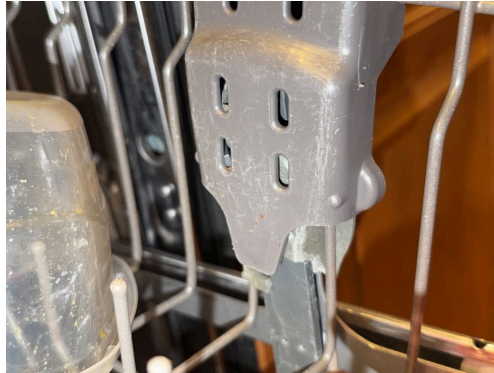
The dishwasher's top rack hardware was damaged, causing the rack to sag. This condition can interfere with smooth rack movement and may prevent dishes from being positioned or cleaned properly. Repair or replacement of the damaged hardware is recommended.

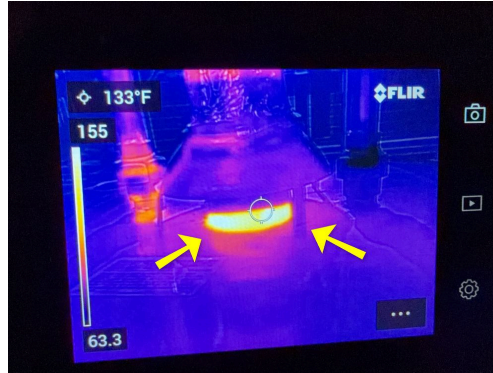
The water heater flue appears to be properly drafting during the inspection when observed with infrared

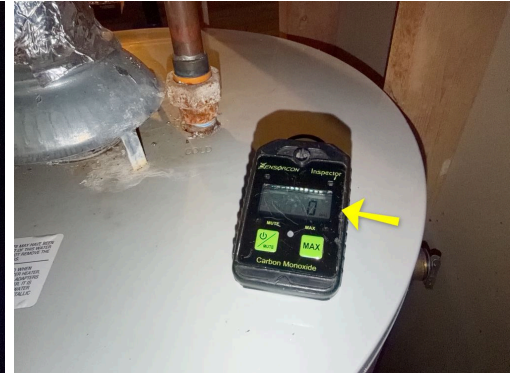
No elevated carbon monoxide readings during inspection near water heater

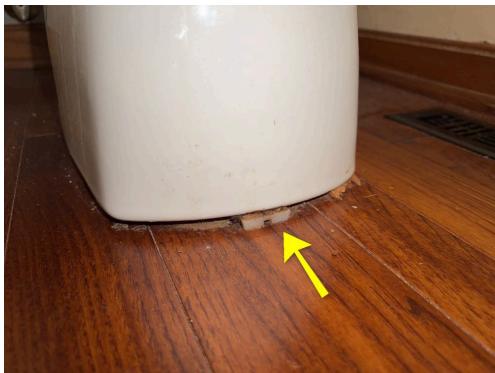
**Location:** 1st Floor Half Bath

Shims were noted installed beneath the base of the toilet. This typically indicates the toilet was not sitting level on the finished floor. While shimming can be an acceptable method to stabilize a toilet, proper sealing around the base is important to prevent moisture intrusion. Recommend monitoring for any signs of movement or leaks, and resealing if necessary.

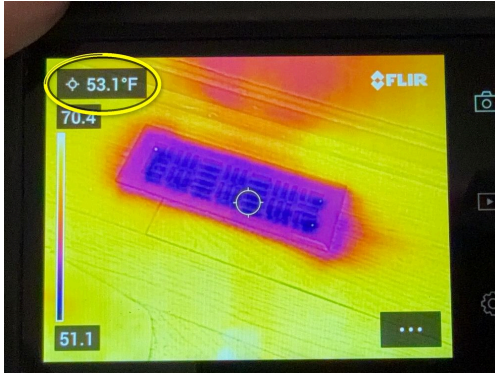
A good temperature differential was observed between the air entering and leaving the cooling system. This indicates the system was providing effective cooling at the time of inspection. Performance can vary with outdoor conditions, system load, and maintenance; continued routine servicing is recommended.

Supply air temperature

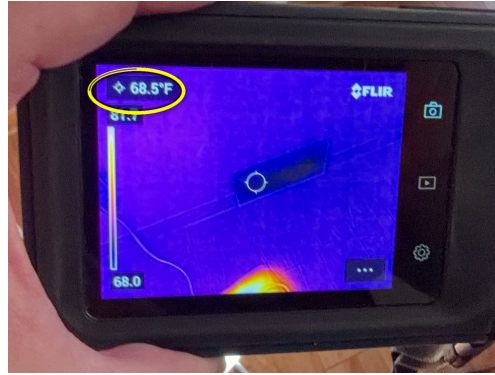
Return air temperature
