***1234 Sample Ave,  
Columbus, OH 43123***

**INSPECTION PREPARED FOR:**  
Smith John & Jane

**INSPECTOR: Chad Auber**

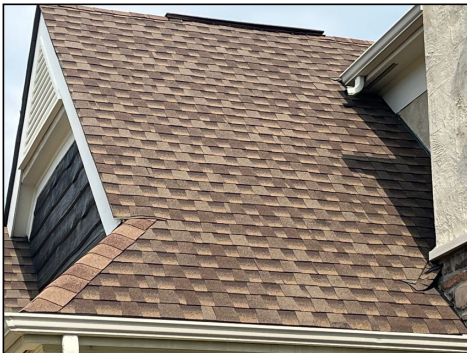
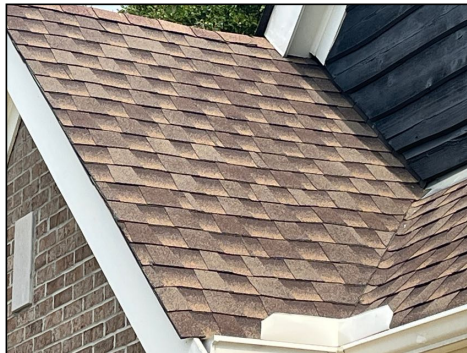
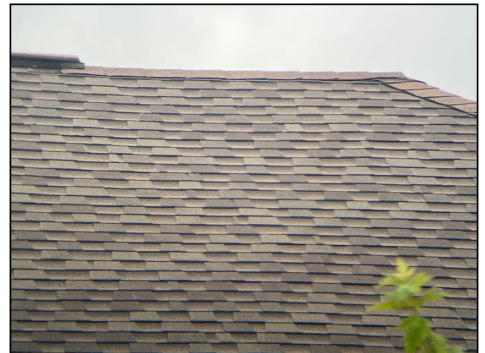
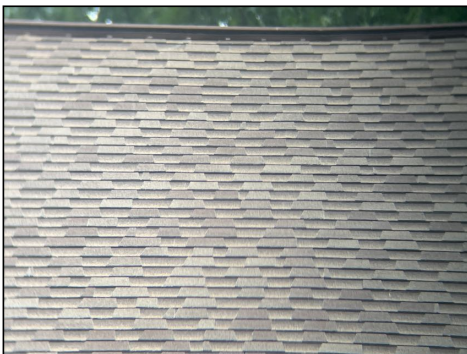
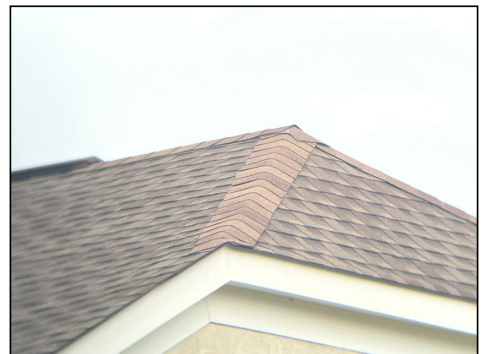
• **Repair/Replace: Minor repairs to the roofing are needed. Damaged and missing roofing material should be repaired. All roof penetrations should be examined and sealed as necessary. Aging or loose flashing can cause leaks, these items should be maintained periodically to prevent water intrusion.**

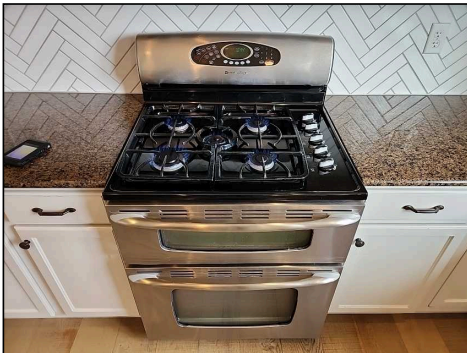
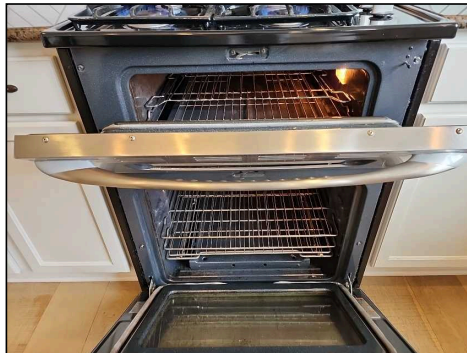
- All burners and oven were operable at time of inspection.**
- Monitor: The gas range is an old unit. While replacement is not needed right away, it would be wise to budget for a new range. In the interim, a higher level of maintenance can be expected.**
- Safety Issue: The range / stove is missing the anti tip device. This is a device that will prevent unit from tipping forward from small child or older adult putting additional weight on door when open.**

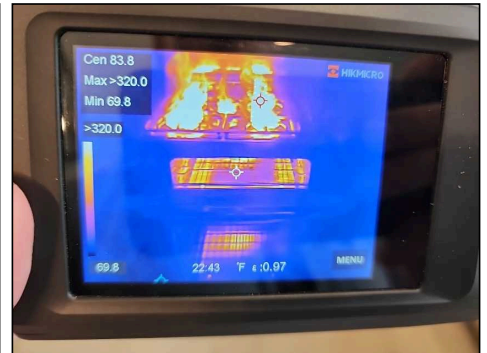
All burners and oven were operable at time of inspection.

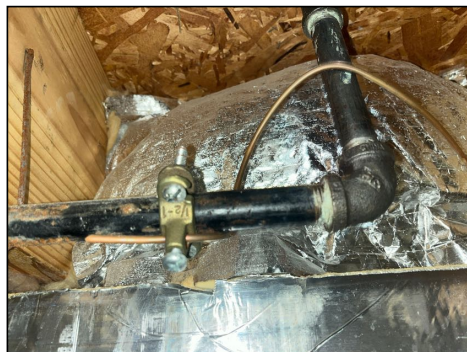
The CSST gas piping appears to be bonded as recommended.

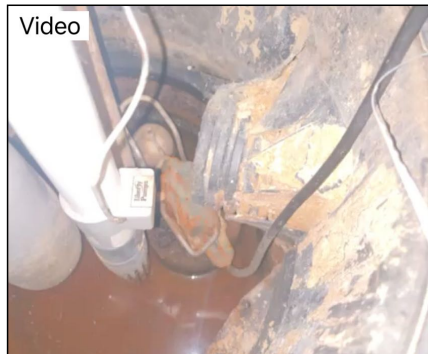
Sump pump tested ok by (lifting float)

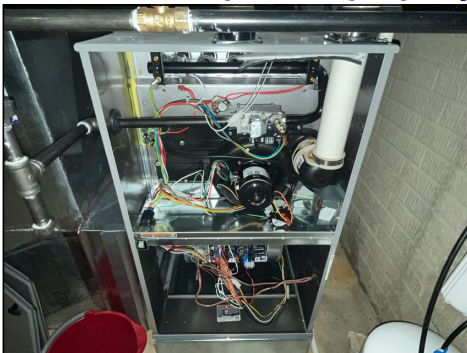
Furnace observation

- **Furnace responded properly to thermostat controls. (off season test)**

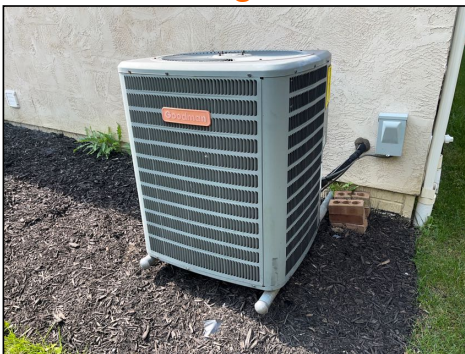
**A/C** unit observation

- **Deferred Cost Item: As is not uncommon for homes of this age and location, the air conditioning system is relatively middle aged. It may require a higher level of maintenance, and may be more prone to major component breakdown. Predicting the frequency or time frame for repairs on any mechanical device is virtually impossible. If the compressor fails, or if breakdowns become chronic, replacing the entire system may be more cost-effective than continuing to undertake repairs.**

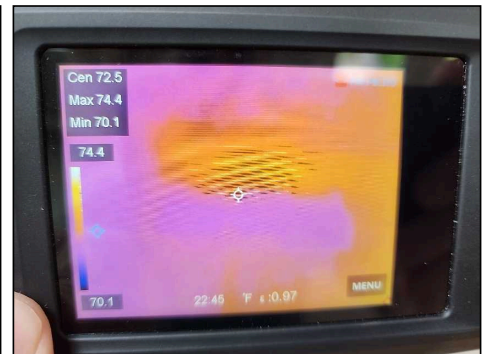
Return temperature 72 degrees

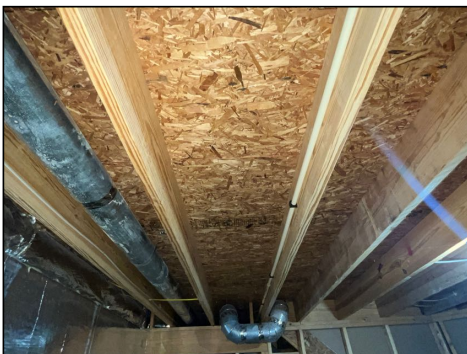
Floor structure observation

- **Repair/Replace:** An unknown substance that appears to be mold was observed on floor joists in the (front basement unfinished storage room). This is usually due to improper ventilation. One (1) square foot of free vent area should be provided for every five hundred (500) square feet of crawl space. Proper ventilation helps control humidity and reduces the risk of rot. Crawl spaces can be vented to the building interior or exterior, depending on crawl space configuration. Mold like substance should be sealed or removed. (Recommend further testing to help identify the substance and the scope of clean up that may be needed)

- **Mold Air Test:** When mold like substances are present and/or moisture intrusion has been observed or reported, it is recommended that mold testing be performed to help identify any species of mold that may be present inside the home. Molds are found in the air that we breathe, but when concentrated inside the home they can be harmful to some people. Once mold has been identified and treated or removed, it is recommended that follow up testing be performed to help ensure that an adequate removal or mitigation has been performed.
